KSC Engineering Directorate
Materials Science Division

Space Spalls

STS-120 International Space Station (ISS) Starboard Solar Alpha
Rotary Joint (SARJ) Debris Analysis

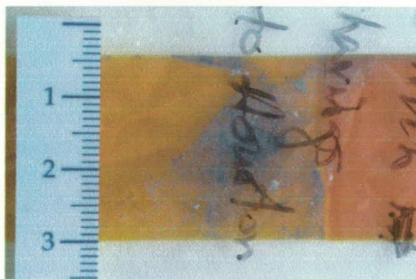
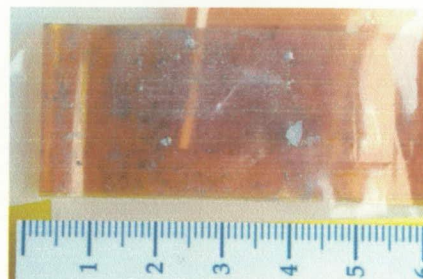
- Following landing and de-stow, Boeing KSC M&P delivered the samples to the Materials Failure Analysis Laboratory.
- Three sample tapes were received for analysis and were photographed, as-received.

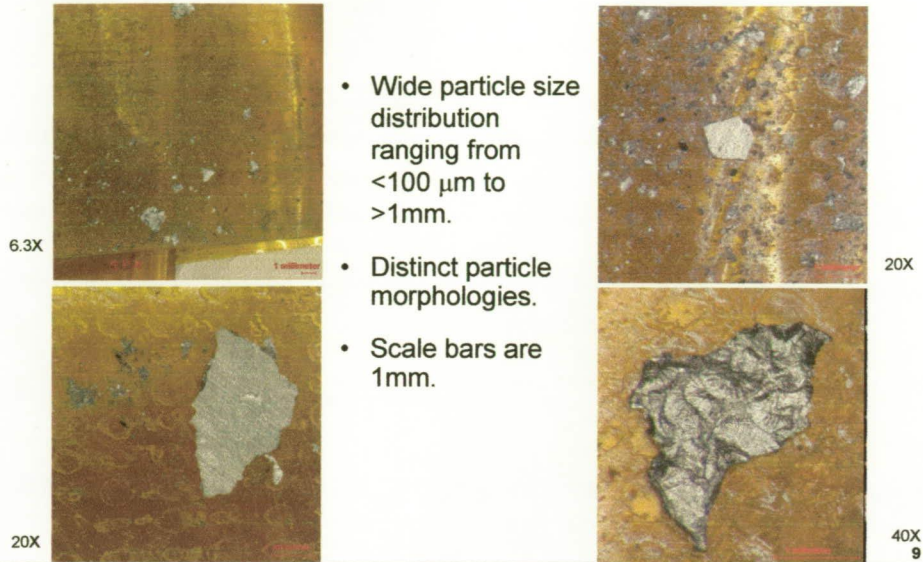
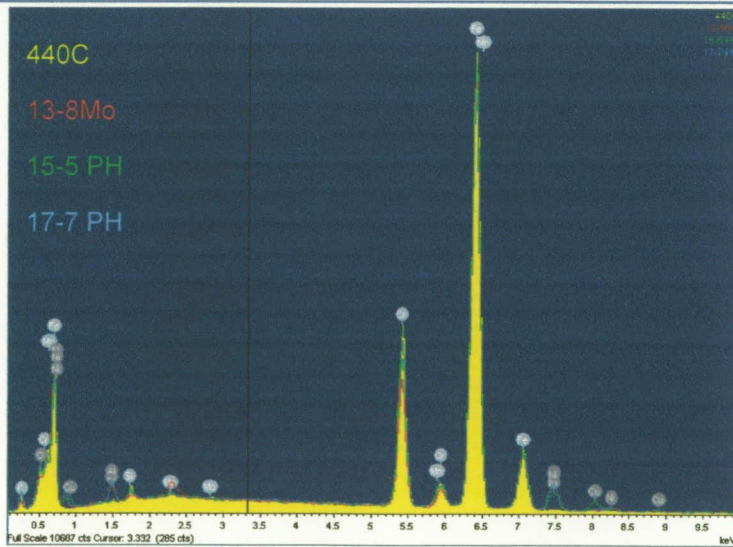
Representative particles from the tapes.

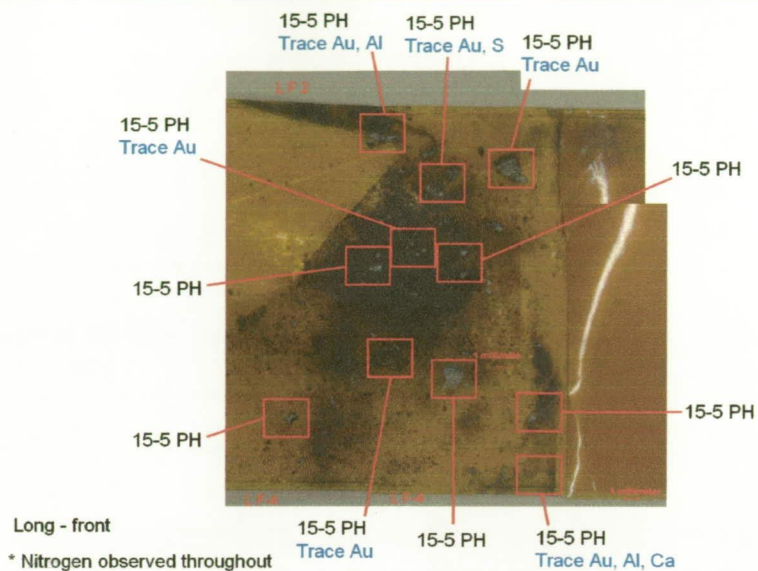
Chemical Analysis of Long Front Sample

All 15-5 PH with Nitrogen
No trace elements

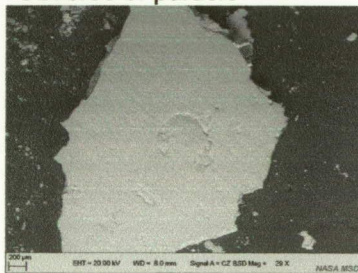
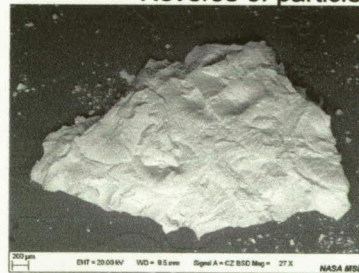
SEM Images of Large Particle from Short Front Sample

Nitrided 15-5 PH surface with machine markings on obverse (L) and flipped over revealing scalloped reverse (R).

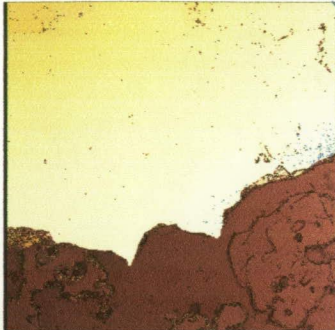
Confocal Microscopy for Particle Thickness

- Confocal microscopy was used for in-situ (non-destructive) thickness measurements at 100X magnification of several particles.
- Particle thickness ranged from 100 to 260 μm , however minor margin of error may exist from the possibility of particles lifting off tape or being imbedded into tape.

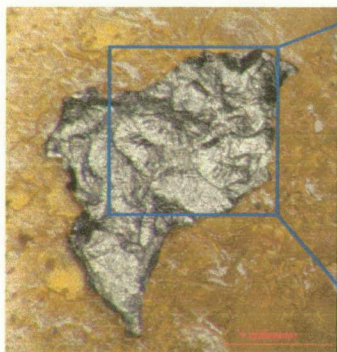
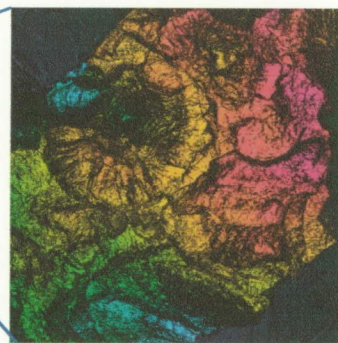
Confocal Microscopy for Surface Topography

Confocal microscopy was used to study the relative heights on the fragment fracture surface. Image on right shows the topography using the visible spectrum, with the highest areas in red/pink and the lowest areas in dark blue (background).

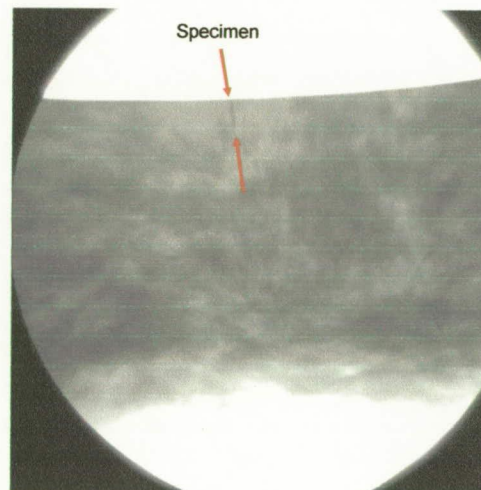
- Two larger fragments were hot mounted in conductive epoxy resin.
- One large fragment was cold mounted in a two-part resin.
- A nitrided 17-4 PH bull gear exemplar was prepared for methodology and microstructure comparison.
- Specimens were ground, polished, and etched to examine the cross sectional microstructure.
- Real-time X-ray was utilized to locate the specimen in the metallographic mount and provide orientation and progress during polishing (right).
